1. AGENCY USE ONLY (Leave blank)		2. REPORT DATE Febraruy 2001	3. REPORT TYPE AND DATES COVERED Inspection	
4. TITLE AND SUBTITLE Lower Granite Dam Radial Gate Inspection and Testing			5. FUNDING NUMBERS

# Lower Granite Dam

## Radial Gate Inspection and Testing

US Army Corps of Engineers, Walla Walla District

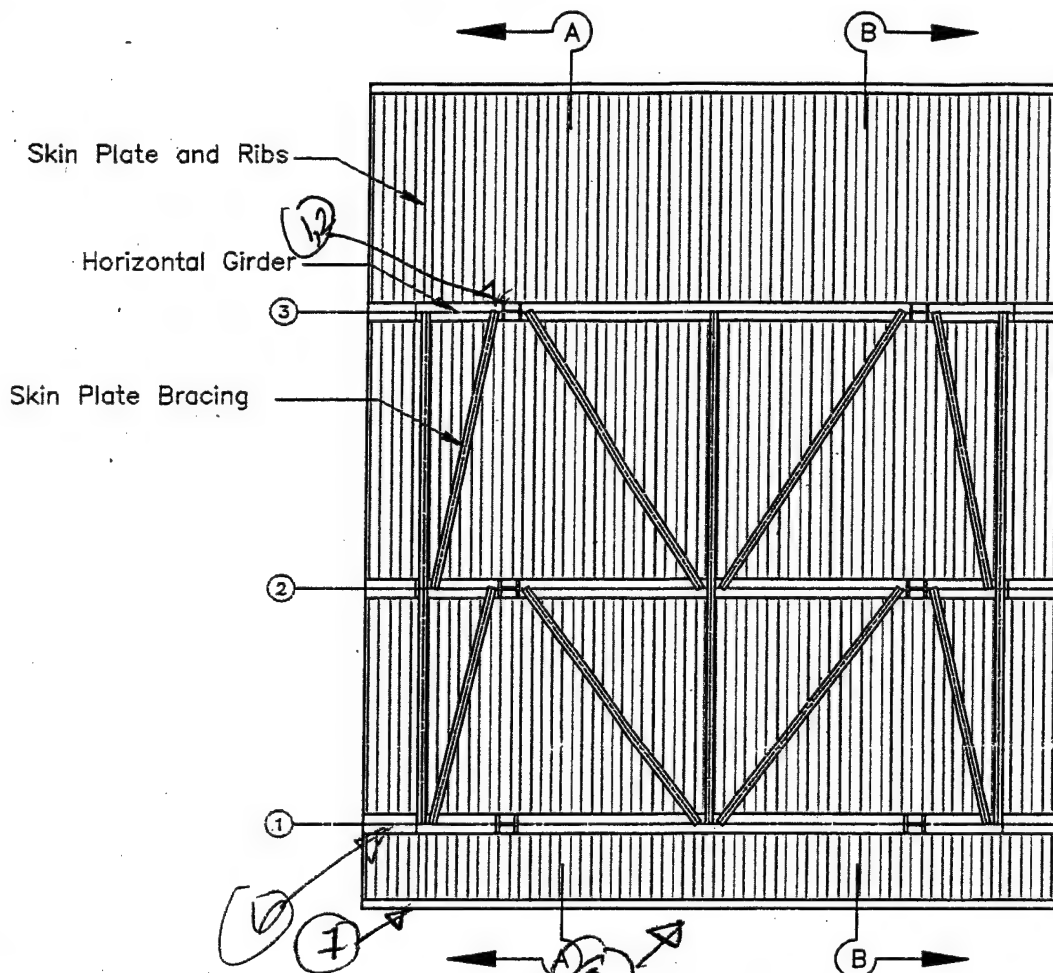
Gate No. 1 Downstream Elevation

① leaking Gate @ Bottom ②

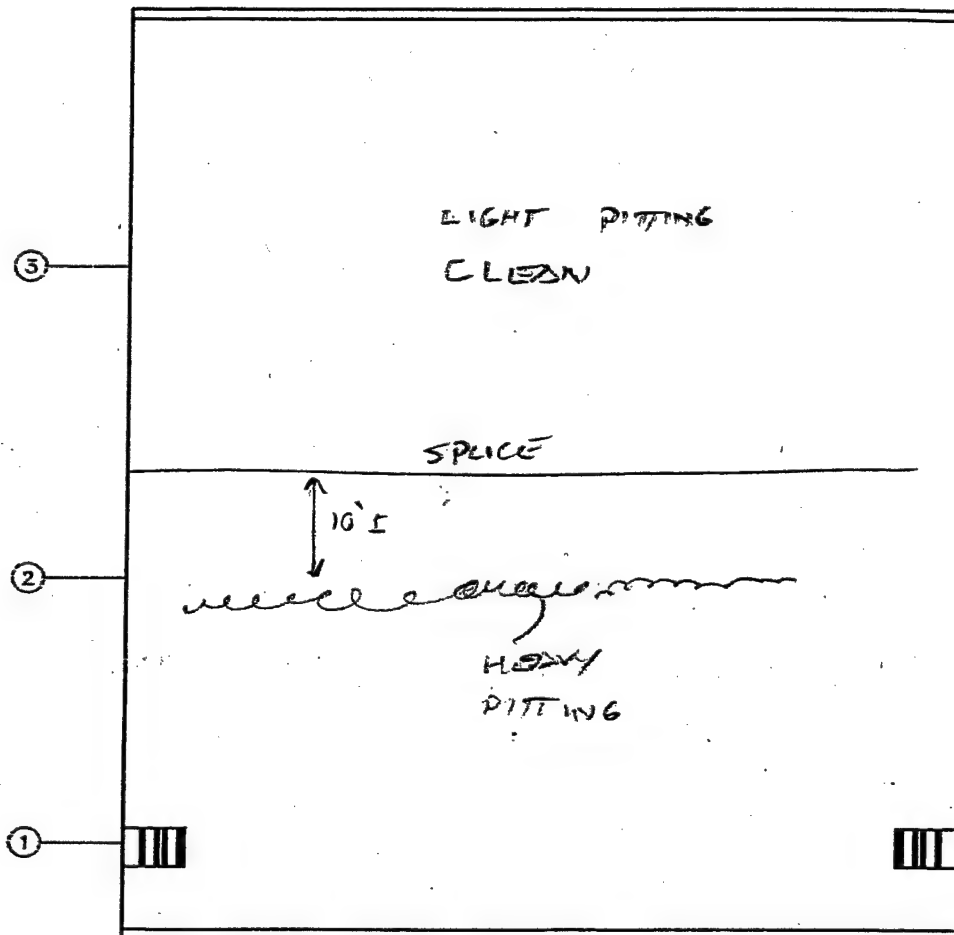
Gate No. 1 Upstream Elevation

HEAVY PITTING @ 10' BELOW SPICE / TOP OF OTHER GATES

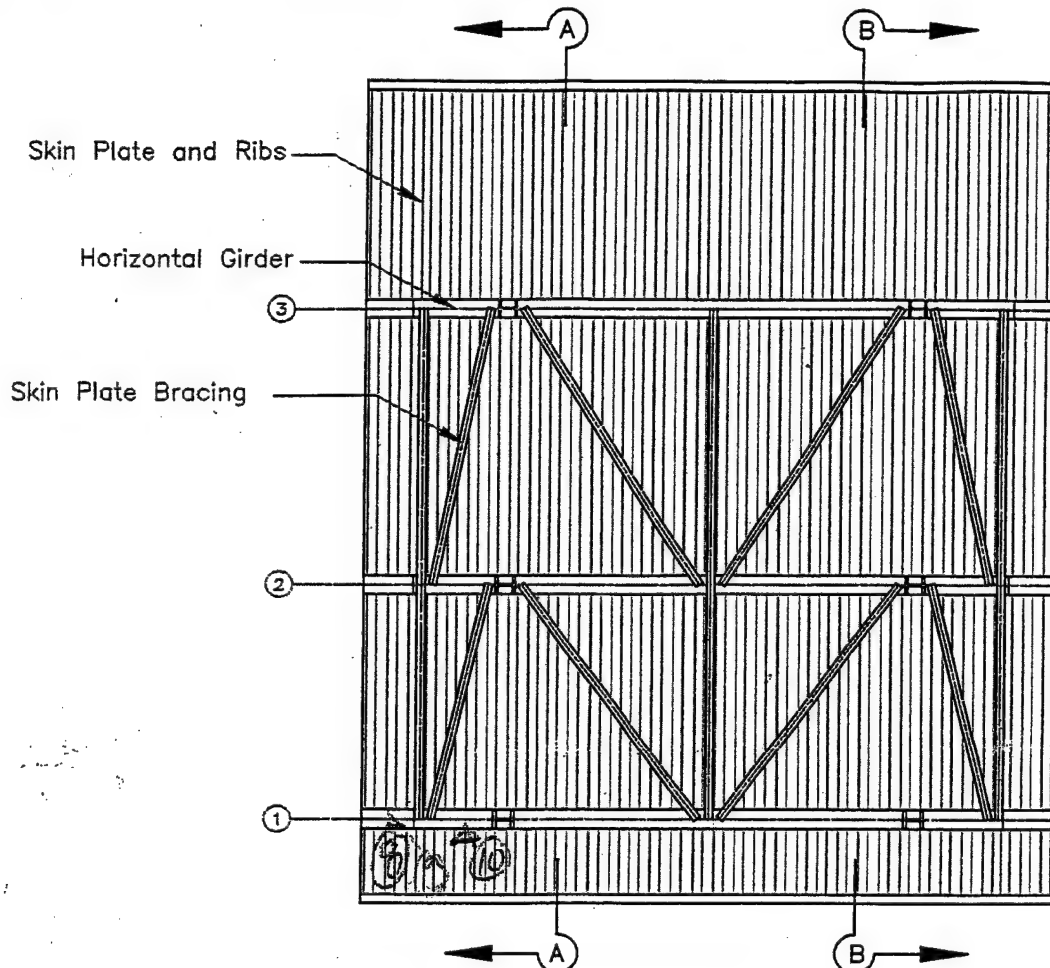
Gate No. 5 Downstream Elevation

① Leak in side seal, on top girder  
② ponding water @ middle  
③ ponding water overall  
④ ponding water in bottom girder  
⑤ side seal, intact  
⑥ bottom seal ✓ from R→L  
⑦ ⑧ ponding in purlins & bottom gate

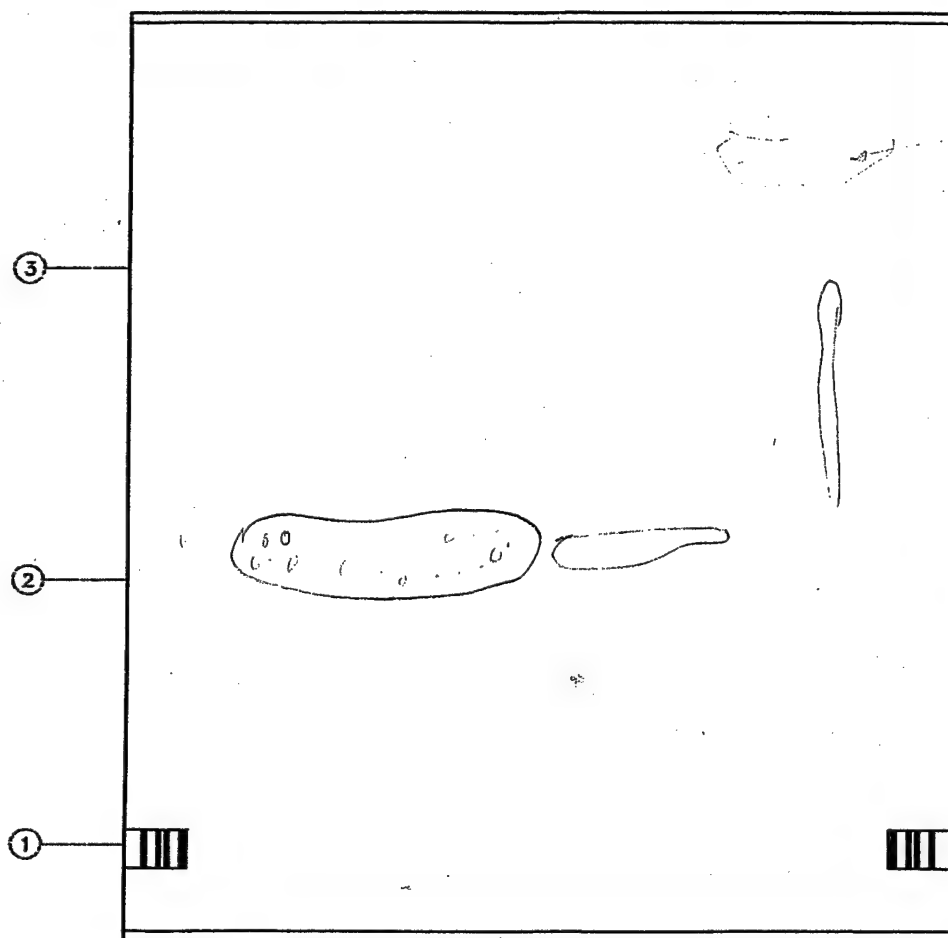
Gate No. 7 Upstream Elevation \_\_\_\_\_

- CORROSION PITS ARE IN GROUPS.  $\frac{1}{2}$  -  $\frac{1}{4}$ " DEEP
- Cables on LEFT SIDE: High Vibrations
- BOTTOM 3rd PITS ARE EVERY  $1\frac{1}{2}$  - 2' ON AVE.

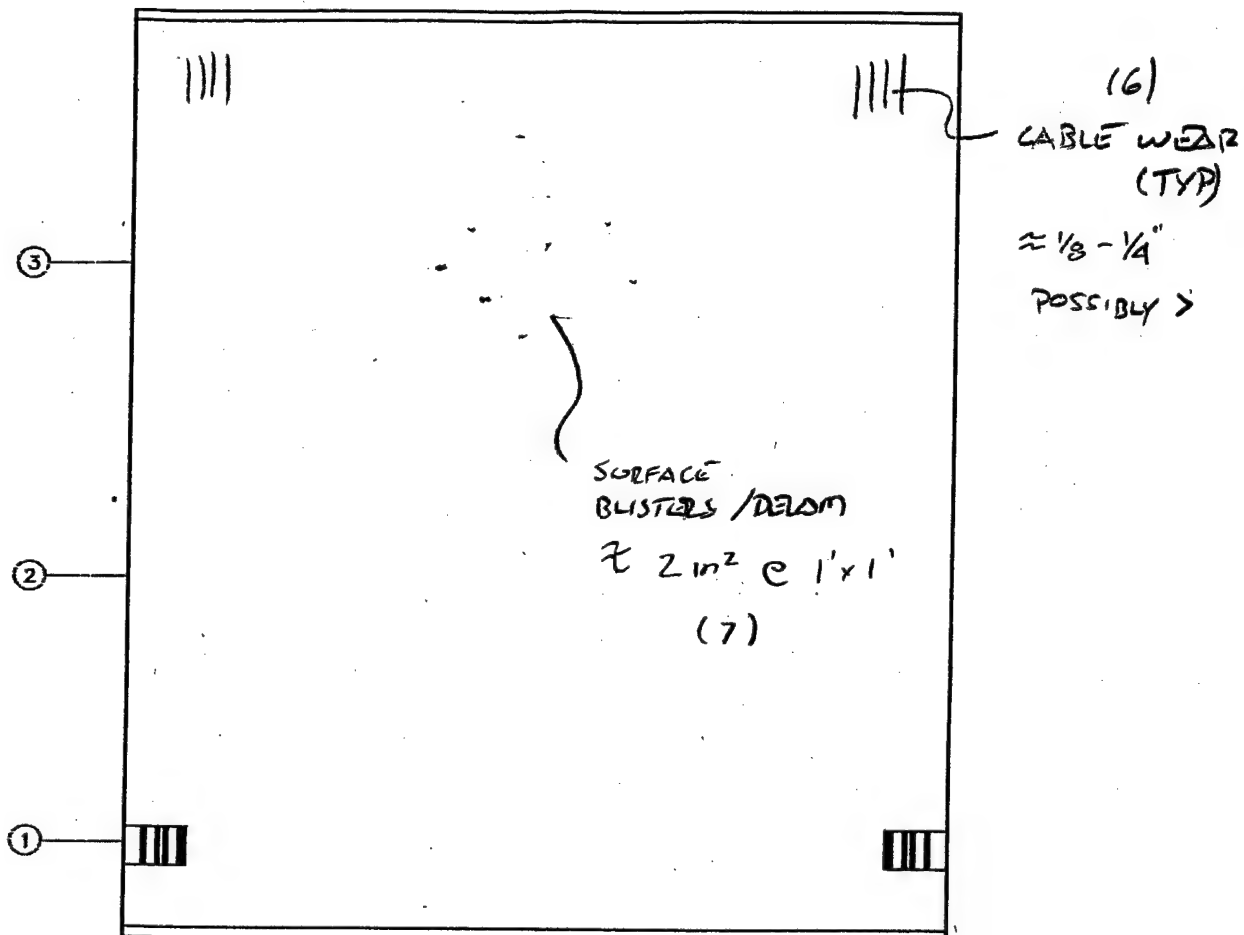
Gate No. 8 Upstream Elevation

DEEP PITTING UP TO 1/4" AT TOP

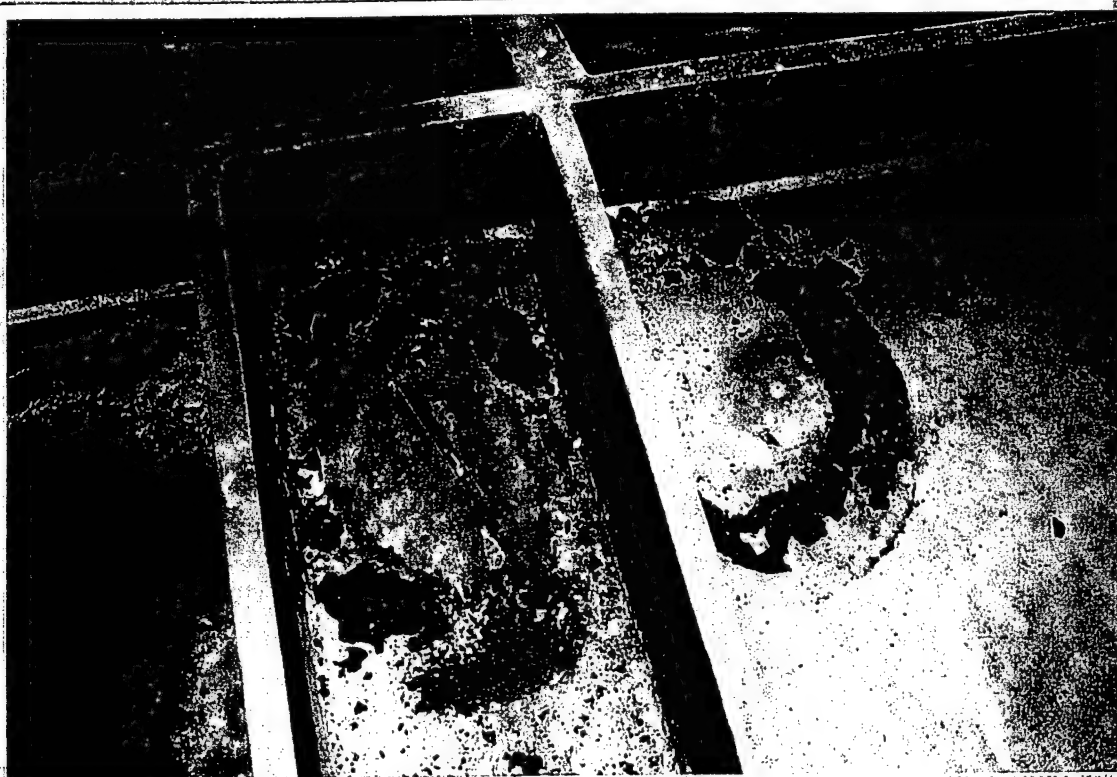
1-3

Gate 1  
Middle horizontal girder, right side,  
between stiffeners at radial strut  
connection. Delaminated paint and  
light corrosion due to poor drainage.

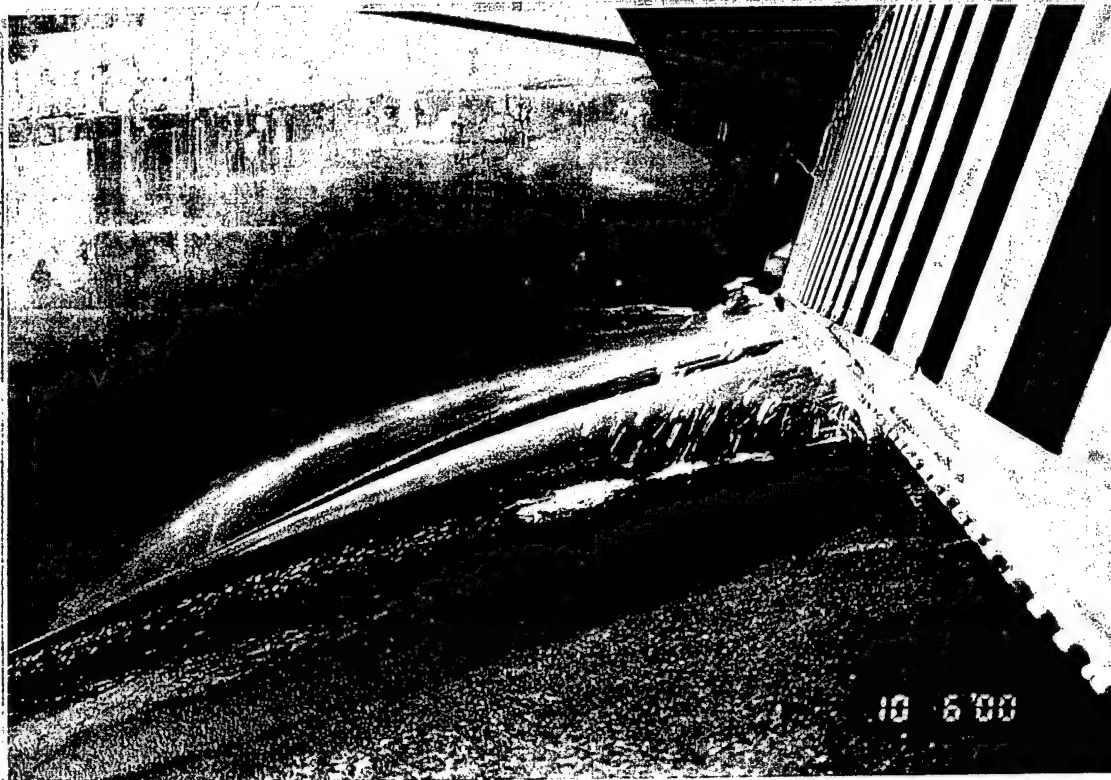
**Gate 1**  
Leak at center construction joint in  
spillway monolith.

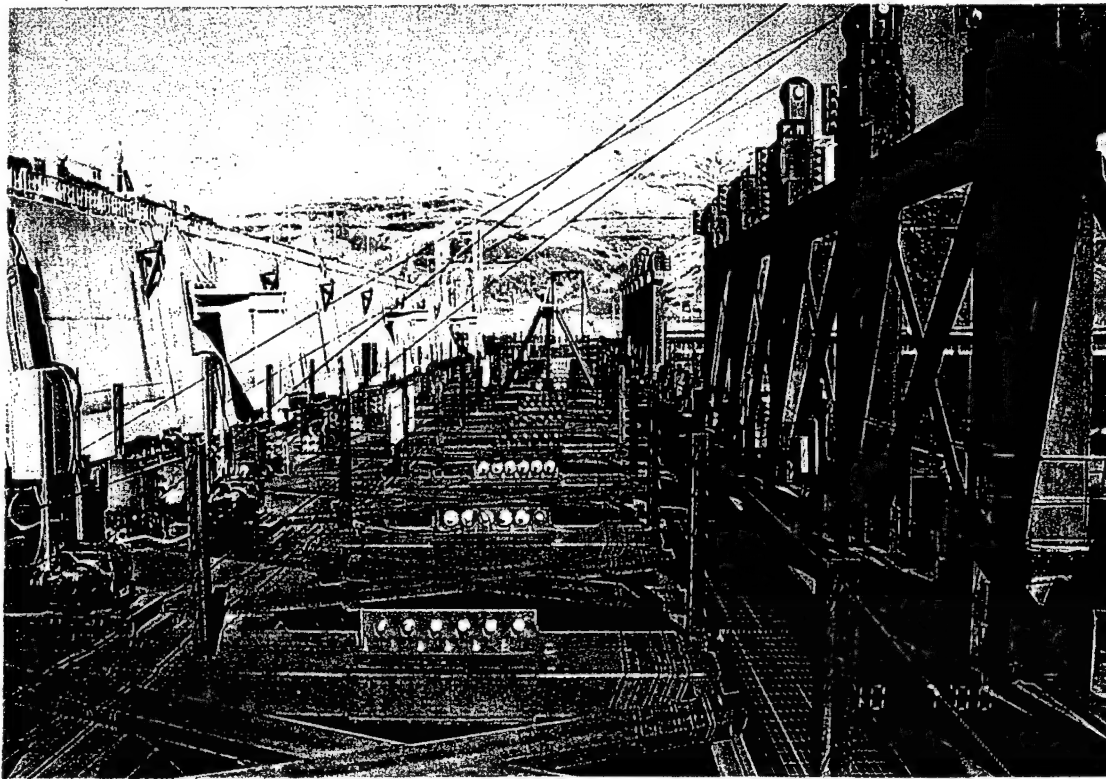
Gate 1  
Surface collector installed at Gate 1.

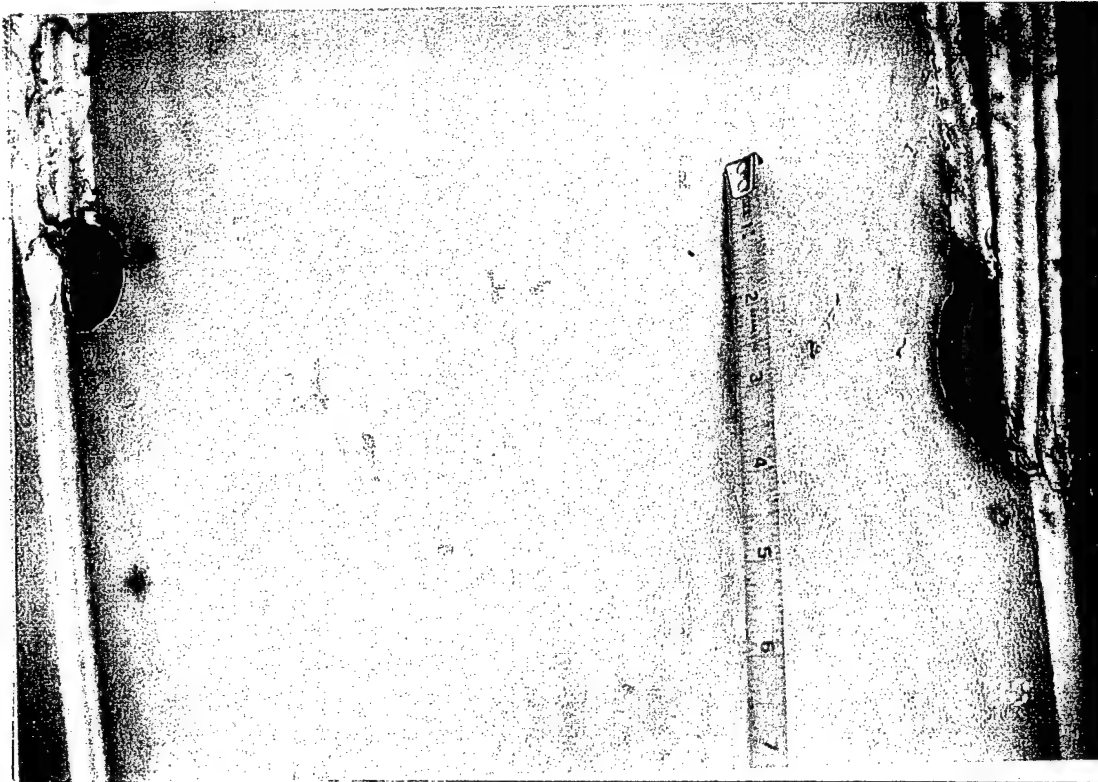
**Gate 2**  
Left frame, Brace H. Copping in brace  
at weld to top radial strut. Light  
corrosion at isolated spots.

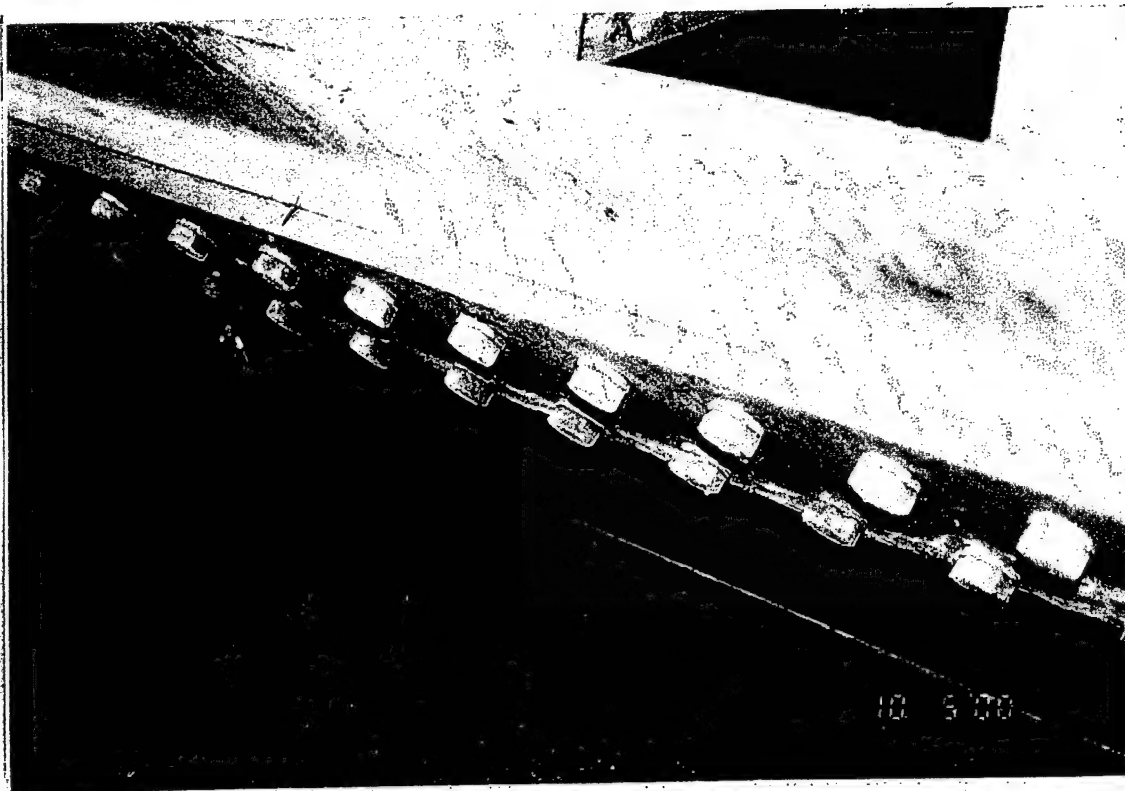
Bottom seal closure plate looking  
upstream. Standing water between  
closure plate, purlin webs and  
skinplate. Typical. Leak at center  
const. joint in spillway monolith.

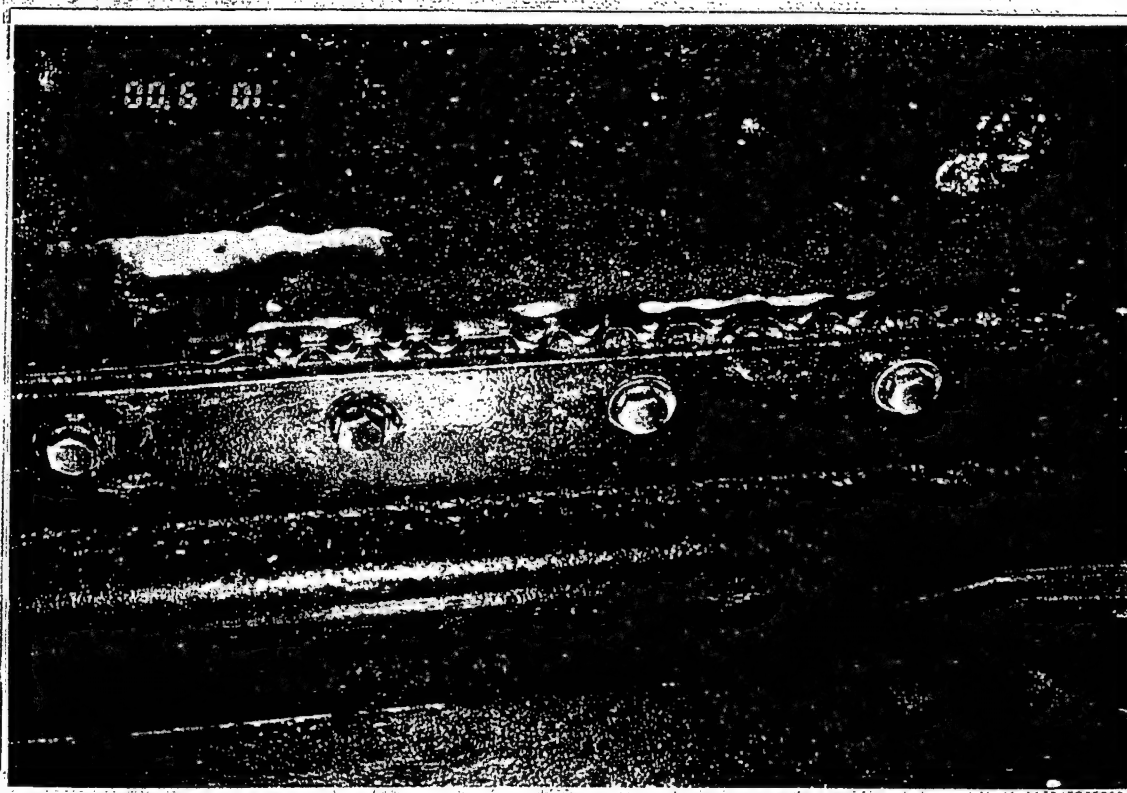
**Gate 2**  
Upstream side of left side seal. Light corrosion and pitting on skin plate.

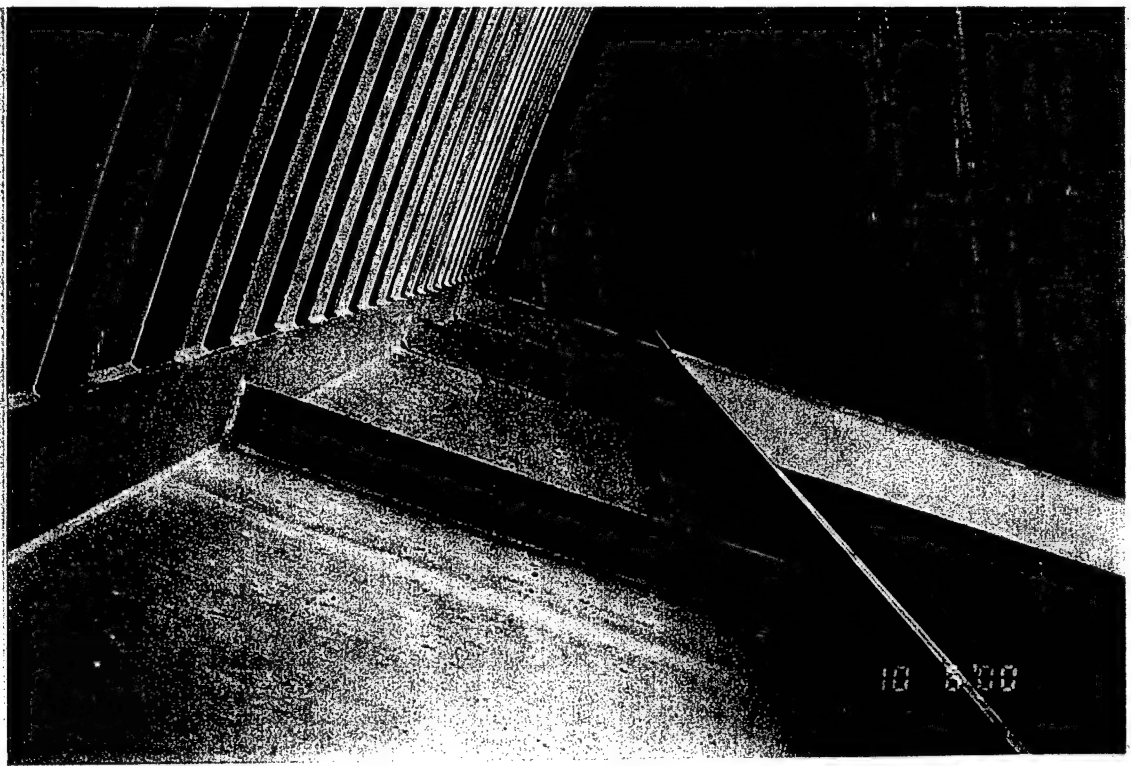
Gate 6  
Top horizontal girder looking toward  
left frame, typical

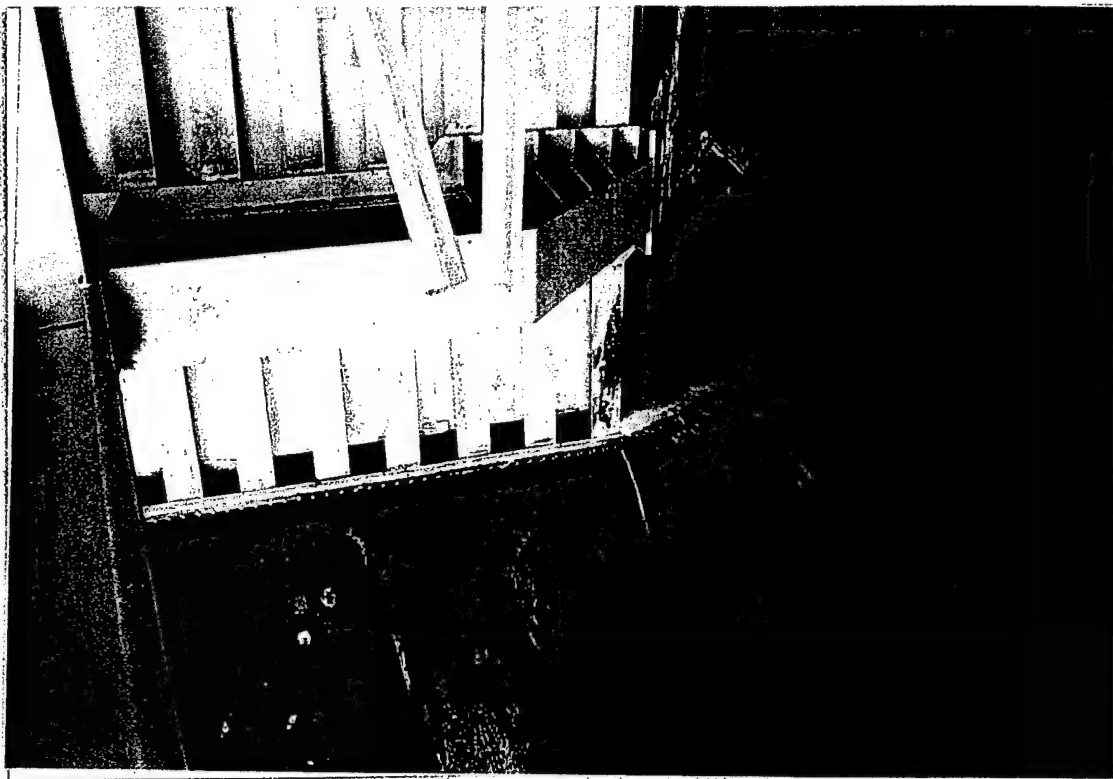
Gate 8  
Bottom left corner leak.

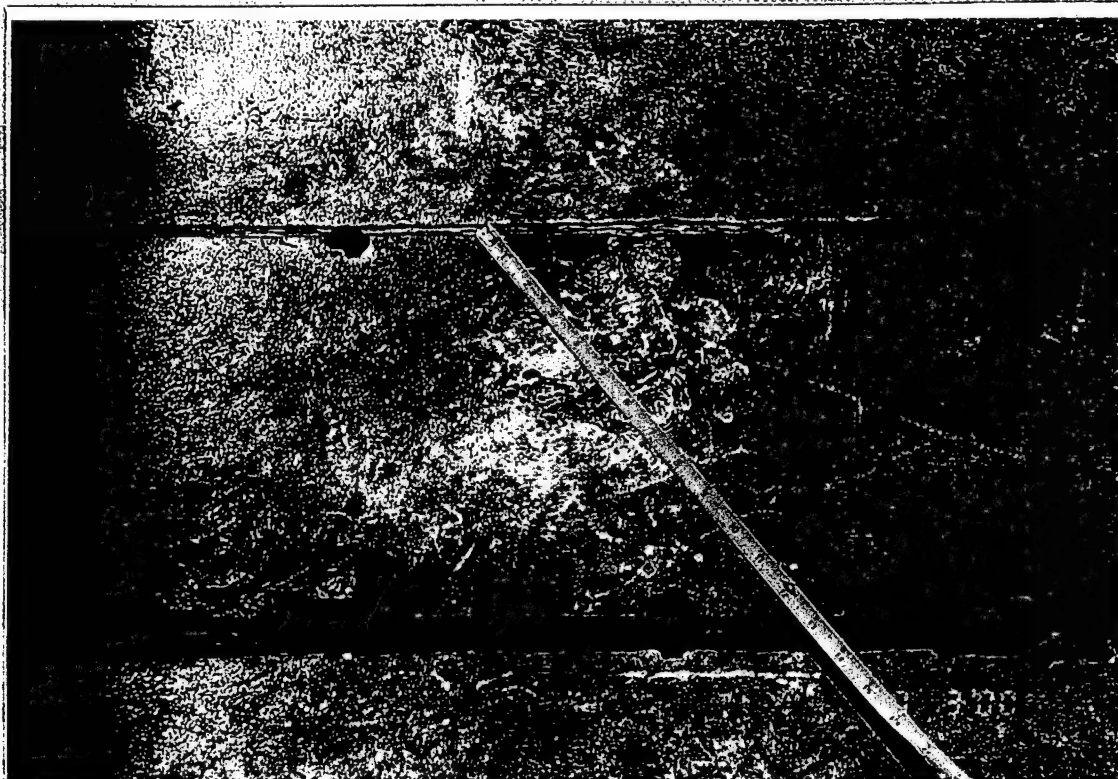
8-25

Gate 8  
Skin plate pitting near wear plate,  
typical.

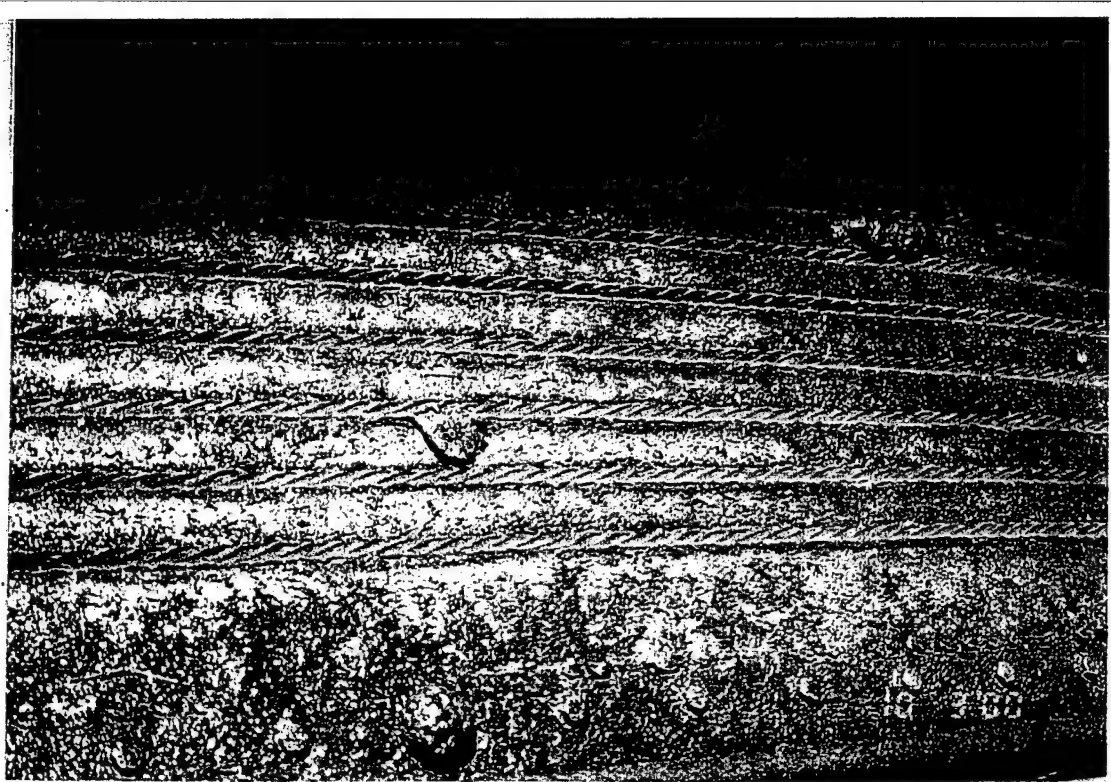
8-29

Lower Gate 8  
Granite Typical wear plate condition. Light  
Dam grooves due to cable wear, light to  
10/03/00 moderate corrosion.
